## **Hazar Lake Sunken City**

Çiğdem Özkan-Aygün

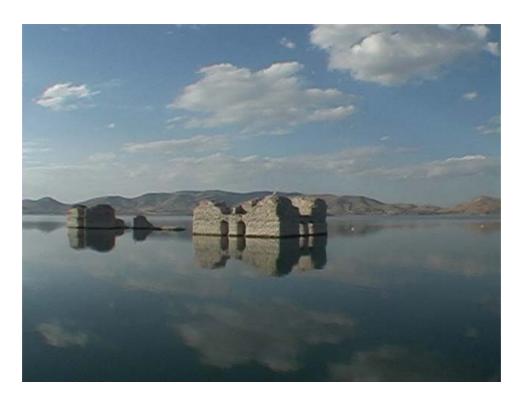
Fig. 1

The investigation of the site was begun at the two towers (Fig. 1) and the result of the dive provided evidence of fortification walls with small rooms on the interior as well as the main gate of the city. The two towers were the gate-houses which flanked the city gate and were built 20 m apart on an east-west axis with the eastern gate house on an L-shaped floor-plan. The brick towers, or gate-houses, are constructed of bricks that are 40 centimeters long by 40 centimeters wide by 4 centimeters thick and are joined by mortar that is 4 centimeters thick. They seem to have been roofed with low vaults as there is evidence of a *pennaculum*. The gate-houses, at initial inspection, seem to have been three storied buildings, with the upper two levels containing arched windows. The lower level walls had embrasured loopholes instead of arched windows. The floor between the two upper stories is quite distinct on the interior where the joist holes for the floor are visible. The lower levels are accessed by a circular stairway. Three table amphora of different dimensions were found at the very bottom of the stairway (Fig. 2) and were similar to the Byzantine table amphora found on the 11<sup>th</sup> century Serçe Limani shipwreck.<sup>3</sup>

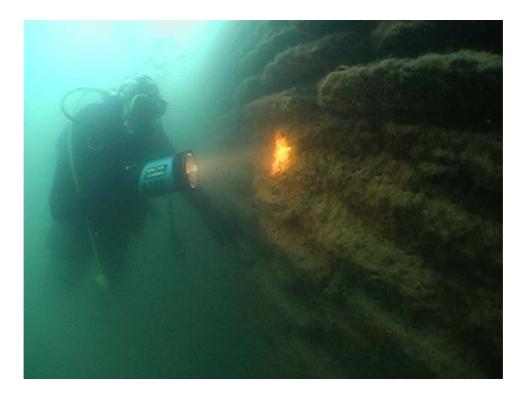
Fig. 3

The protective circuit wall, which is currently underwater, was 5 m in height and constructed of brick and mortar (Fig. 3) with ashlar masonry in the lower course of the wall (Fig.4). The ashlar blocks were hardly visible as they were partially

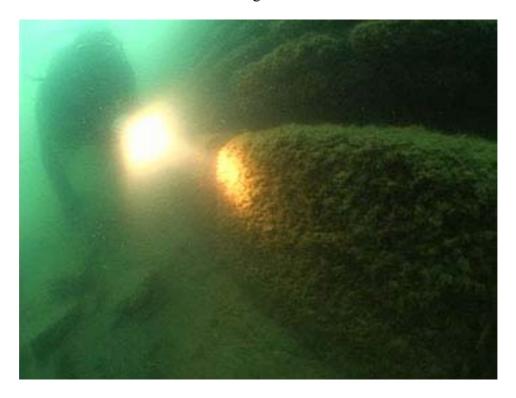
Fig.4

covered with mud. The main wall is interrupted by seven vaulted rectangular rooms each of which are closed with convex walls with an embrasured loophole on each convex wall. The wall extends to the island, turns to the east and runs parallel to the southern shore of the island.
